# Updates, Rehabs Remediation and Hazards

*Douglas Sidwell  
Better Home Inspections  
Cedar Lake, Indiana*

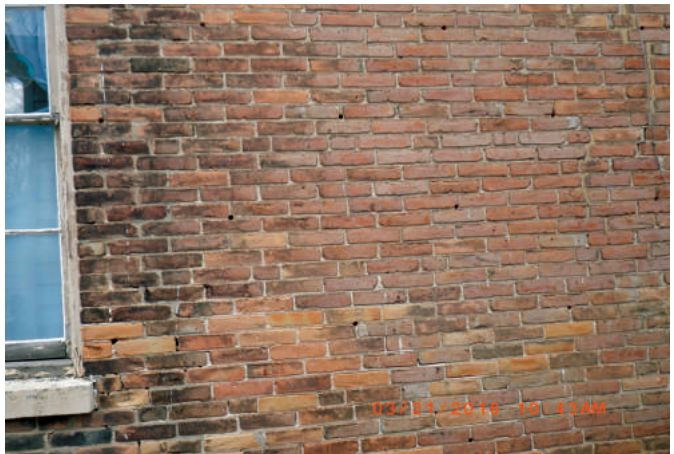
## A HOME INSPECTOR'S RECENT DISCOVERY

Steven Burnett, CRI of Journey Property Inspections, Tecumseh, MI inspected a 120 year old brick wall constructed home. Discovered were random 1/2' drilled holes in one side of the 2 story home. What do you think? Past termite treatment, retrofitted sprayed insulation holes, weep holes, trellis attachment? Send email comments to [journeyinspection@gmail.com](mailto:journeyinspection@gmail.com).
